SUMMARY REPORT

Inspection Address: 456 Your New St, Phoenix, AZ 85018

Inspection Date: 7/3/2009 Start: 12:00 pm End: 4:00 pm

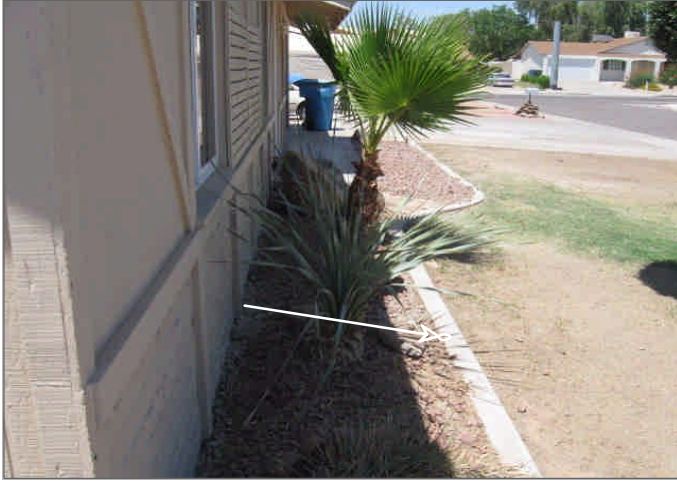
- 2.2 - Areas of the front, back and side yards present a potential safety issue due to uneven grading and holes which should be serviced and corrected.

Figure Set 1 - Minor adjustments of the surface grading to direct surface moisture would be beneficial

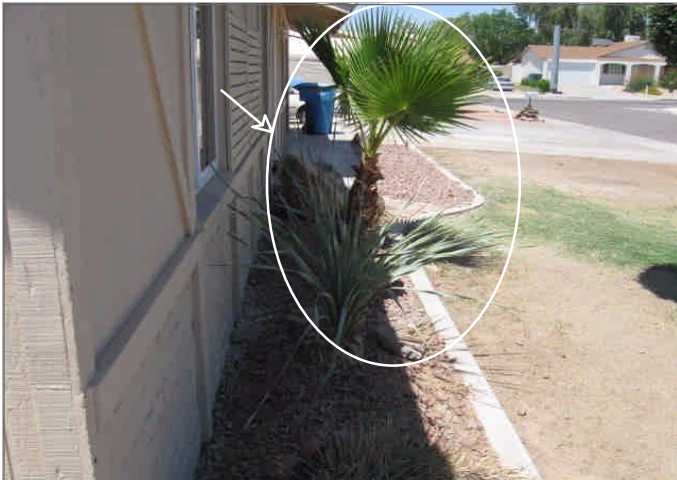
- 2.3 - A tree or bush that is adjacent to the foundation by the laundry room should be monitored for any growth that might affect the foundation.

Figure Set 2 - A tree or bush that is adjacent to the foundation should be monitored

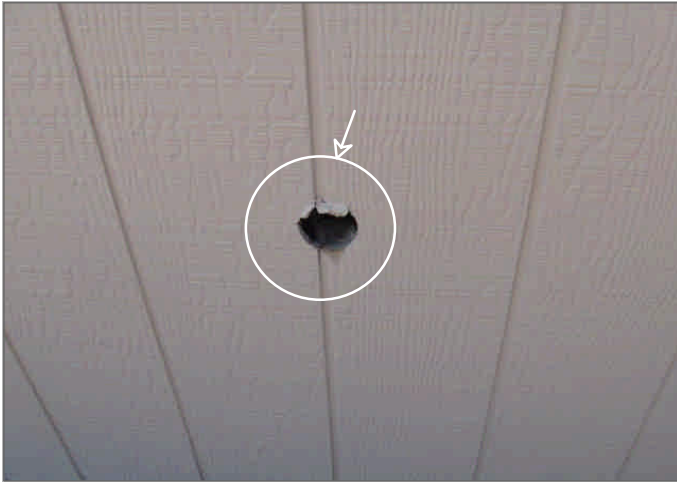
- 2.4 - There are voids in one or more areas on the exterior that should be sealed to prevent moisture or pest entry.

Figure Set 3 - There are voids in one or more areas on the exterior that should be sealed

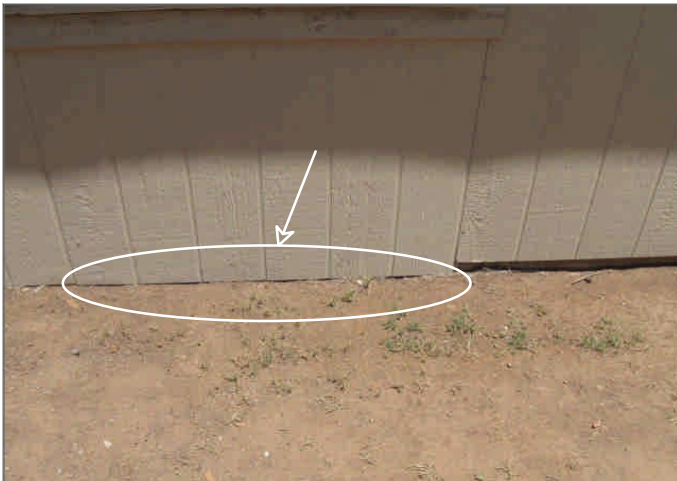
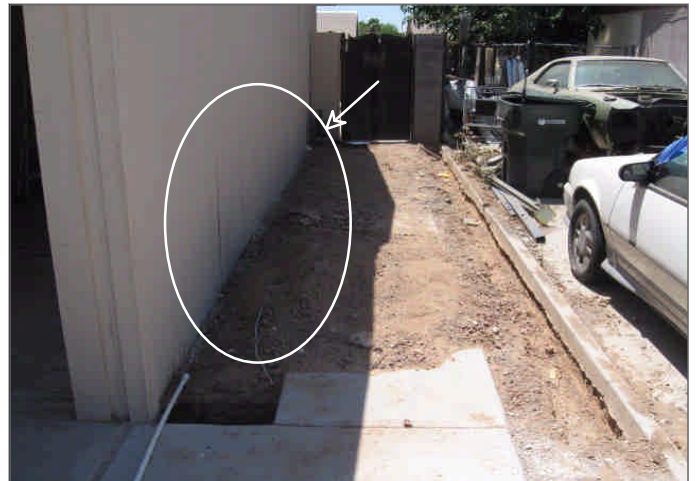
- 2.5 - The siding on portions of the house is in direct contact with or too close to the ground. Siding should end typically 6" above grade. I recommend further evaluation by a qualified and competent contractor with remedy as necessary.

Figure Set 4 - The siding on portions of the house is in direct contact with or too close to the ground

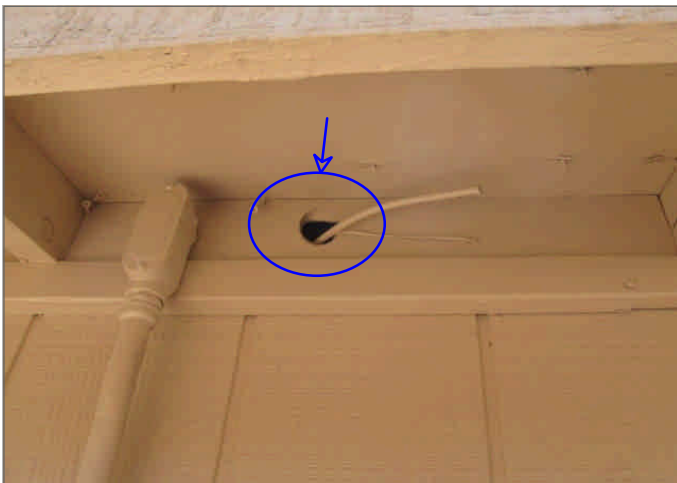
Figure Set 5 - There are cables run through a bird screen that should be sealed to prevent bird or pest entry

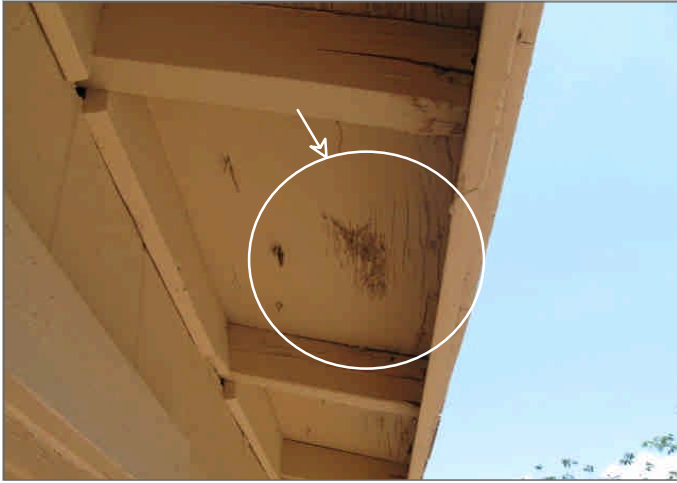
2.7 - Sections of the eaves and soffits are weathered and should be serviced to prevent further deterioration.

Figure Set 6 - Sections of the eaves and soffits are weathered and should be serviced

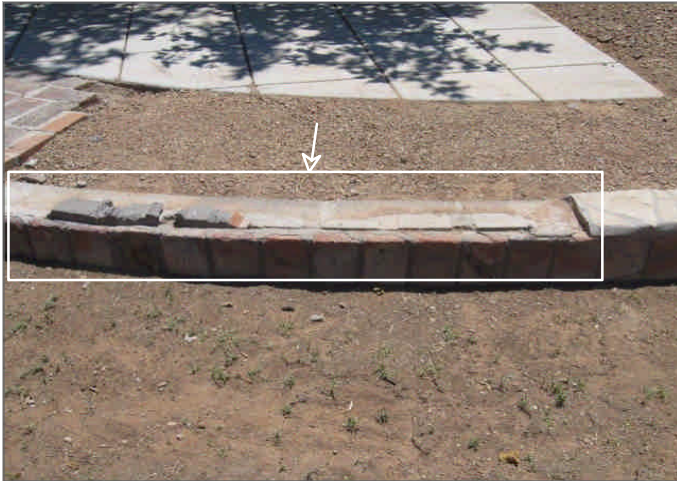
2.8 - The walkways or decorative edging are damaged in various area and should be repaired or replaced.

Figure Set 7 - The walkways or decorative edging are damaged in various areas and should be repaired or replaced

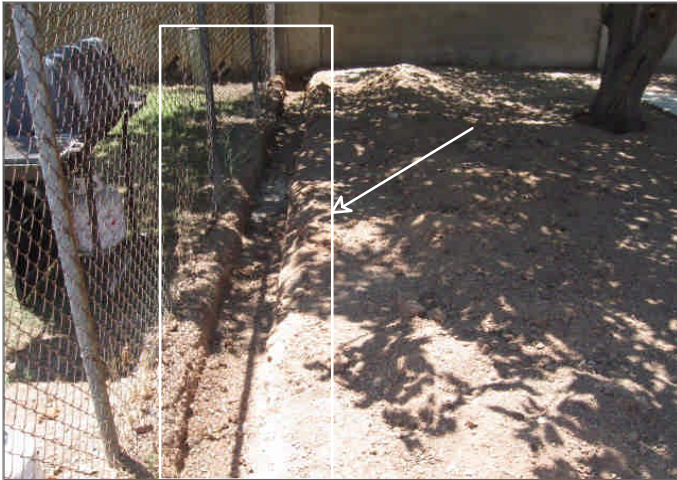
Figure Set 8 - There are open trenches for block walls that present a safety issue for tripping until the block is laid

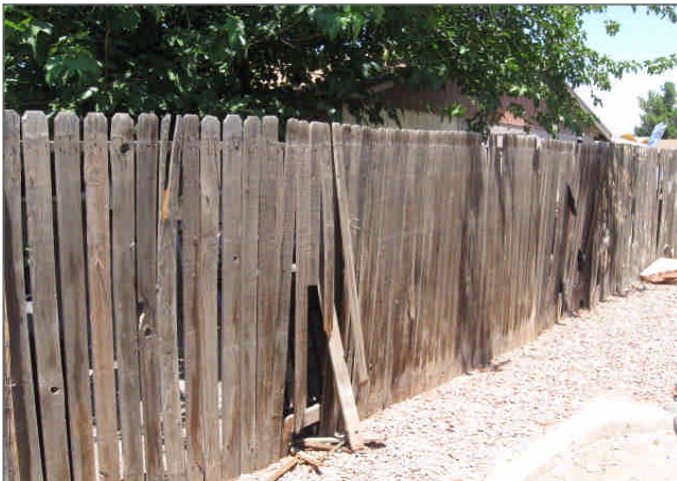
2.11 - The wood fence is missing one or more boards that should be replaced.

Figure Set 9 - The wood fence is missing one or more boards that should be replaced

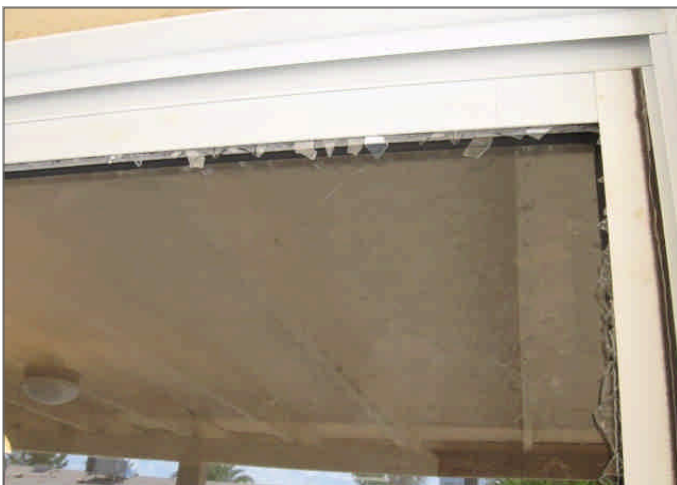
2.13 - One of the glass panels in the slider is broken, and should be replaced with tempered glass.

Figure Set 10 - One of the glass panels in the slider is broken

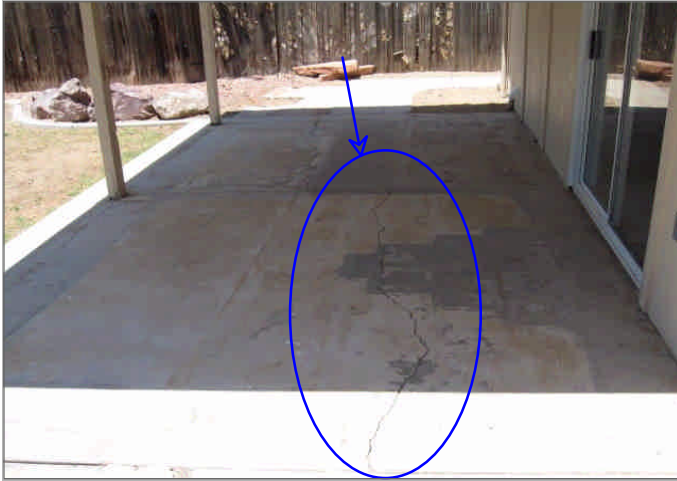
2.14 - The patio concrete is cracked but appears to have settled and is not cracking further. The cracked sections appear to be an addition to the house and not part of the original structural. You may want to check with the prior owners to see if a permit was pulled for this addition.

Figure Set 11 - The patio concrete is cracked but appears to have settled and is not cracking further

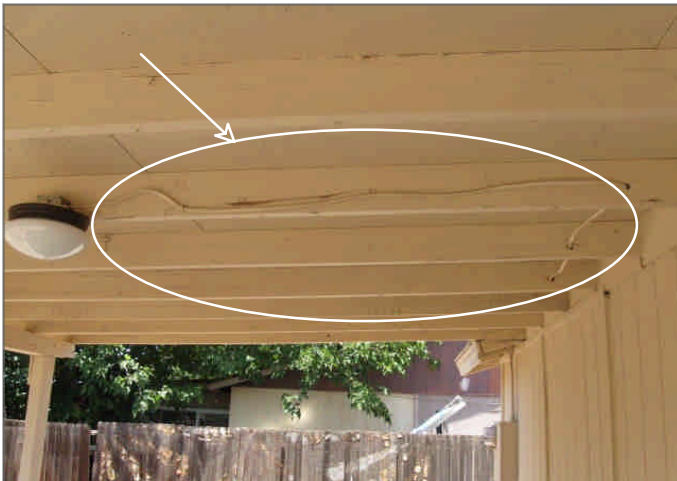
2.15 - There are electric lines on the exterior that are not in conduit and could become a safety hazard that should be repaired or replaced in order to reduce the risk of electrical shock.

Figure Set 12 - There are electric lines on the exterior that are not in conduit and could become a safety hazard

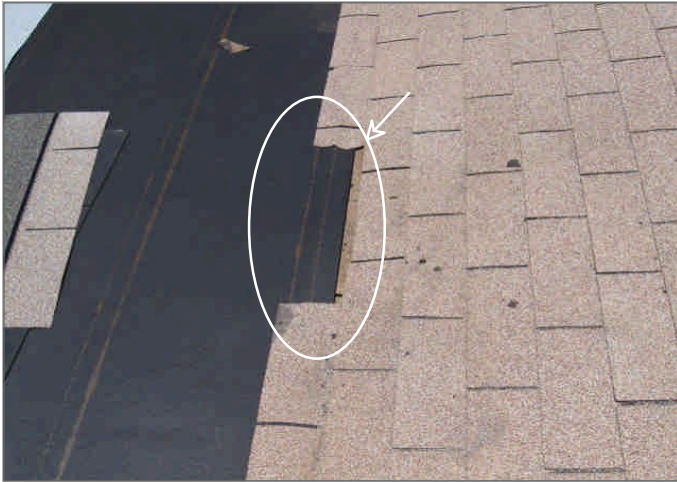
- 3.1 - Some shingles are loose or missing and should be repaired or replaced. We recommend further evaluation by a qualified and competent roofing contractor with remedy as necessary.

Figure Set 13 - Some shingles are loose or missing and should be repaired or replaced

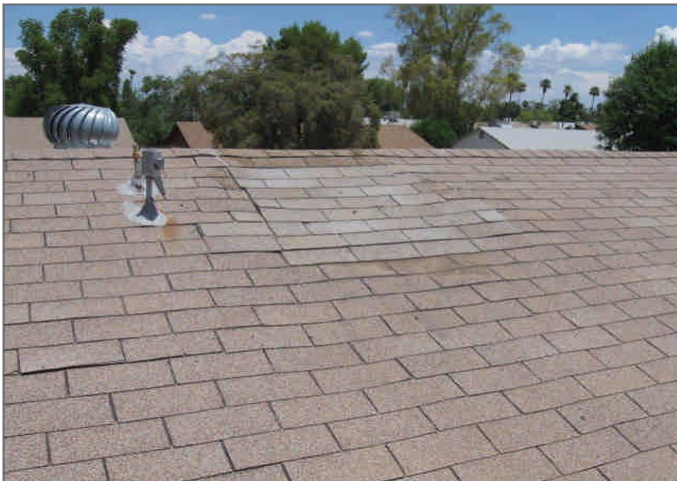
- 3.2 - The ridge or roof line appears to be wavy in silhouette. The area of the roof just below where the evaporative cooler had been installed is also "spongy" to walk on which can be an indicator that the roof underlayment is dry rotted and may need to be replaced. You should consider having a roofing contractor evaluate the roof or comment on this specific feature.

Figure Set 14 - The ridge or roof line appears to be wavy in silhouette and should be evaluated

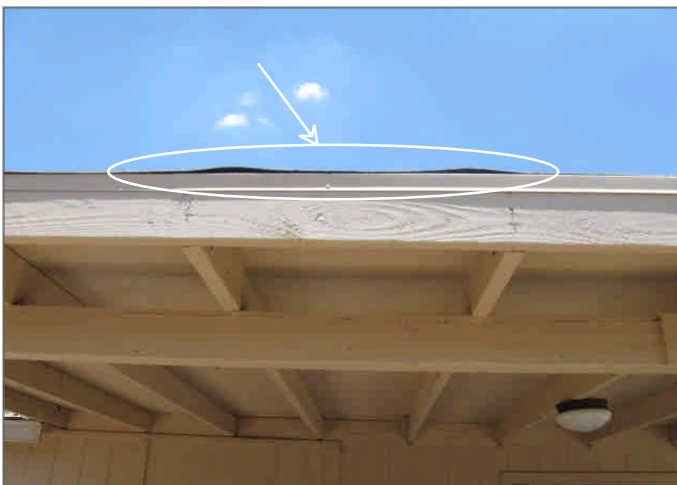
- 3.3 - The roof has a small open horizontal seam, which should be sealed to prevent moisture entry. We recommend further evaluation by a qualified and competent roofing contractor with remedy as necessary.

Figure Set 15 - The roof has a small open horizontal seam which should be sealed to prevent moisture entry

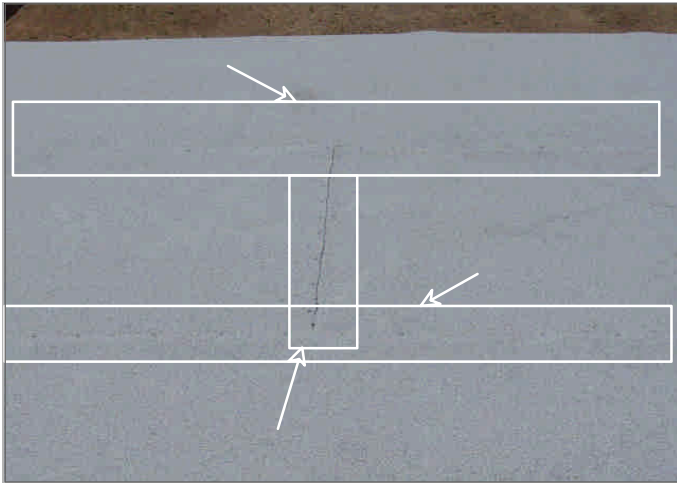
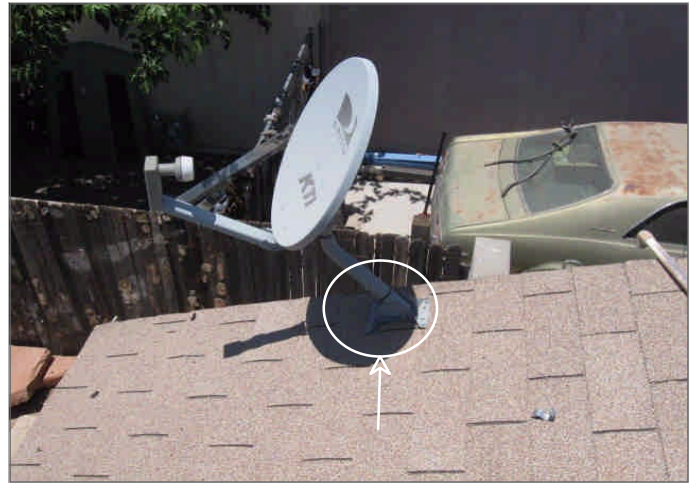
3.4 - There are roof penetrations that should be sealed with mastic to prevent moisture entry.

Figure Set 16 - There are roof penetrations that should be sealed with mastic to prevent moisture entry

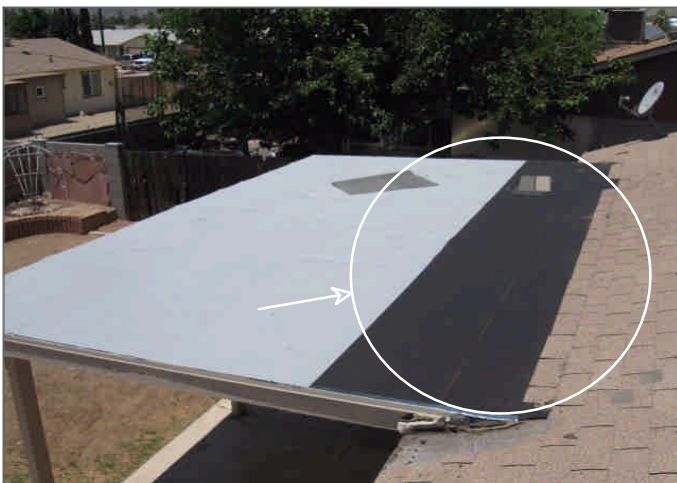
3.5 - A strip of roofing material is missing and should be installed to forestall moisture entry.

Figure Set 17 - A strip of roofing material is missing and should be installed to forestall moisture entry

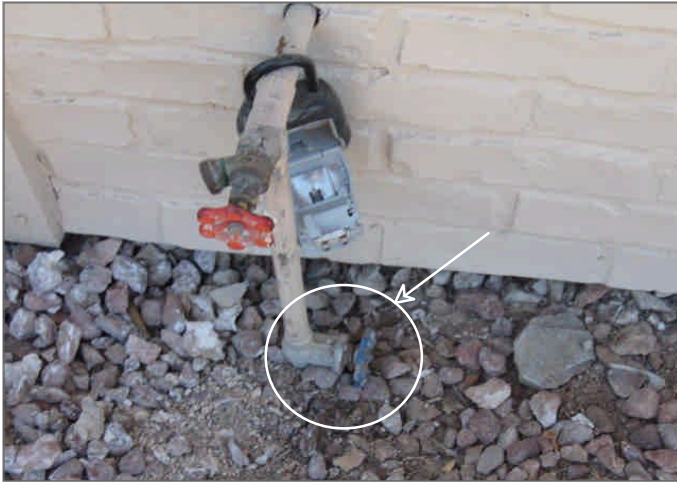
4.2 - The main water shut off valve leaks and does not fully close and should be replaced. I recommend replacement of the shut off valve by a qualified and competent plumbing contractor.

Figure Set 18 - The main water shut off valve leaks and does not fully close and should be replaced

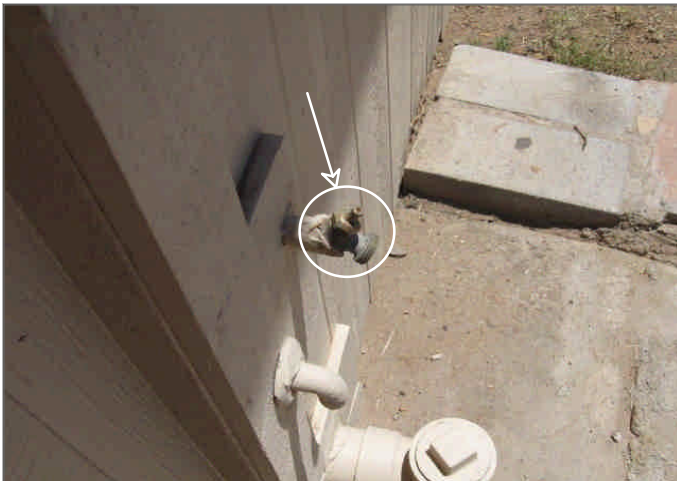
Figure Set 19 - A hose bib is missing a handle which should be replaced

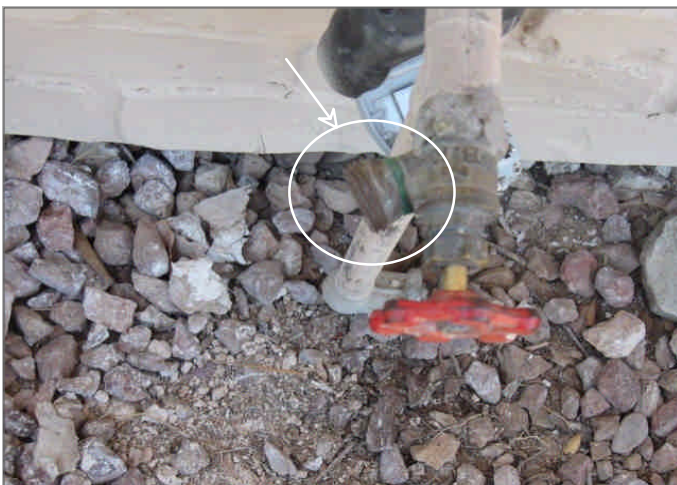
Figure Set 20 - We observed a cross connection in the plumbing system at a hose bib without an antisiphon

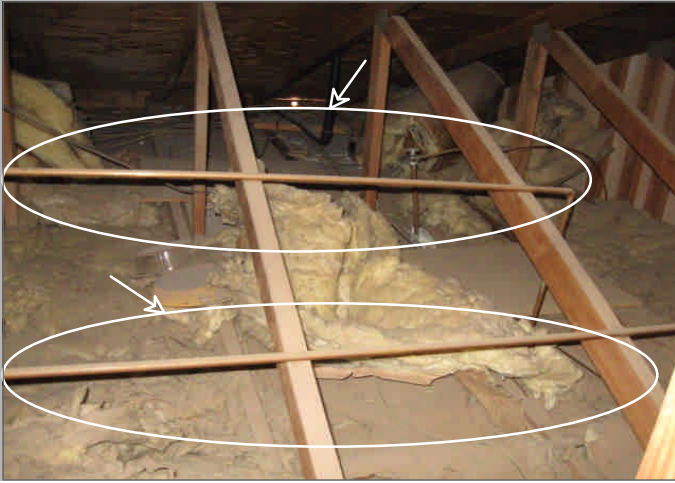
- 4.7 - There are uninsulated hot and cold water pipes running through the attic. We recommend that the water pipes be insulated to guard against freezing and/or energy loss.

Figure Set 21 - There are uninsulated hot and cold water pipes running through the attic

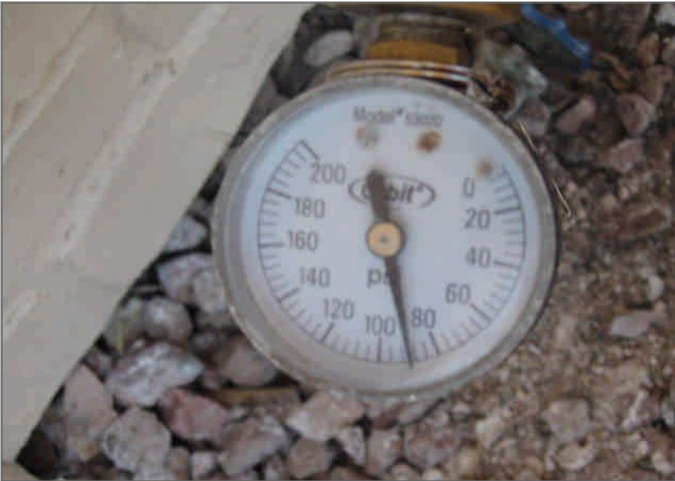
- 4.8 - The water pressure was at or over 80 psi. We recommend that you consult a qualified and competent plumbing contractor about what action you should take regarding water pressure this high. A pressure regulator may be a device which you should install but a qualified plumbing expert would be the specialist to ask this of.

- 4.9 - The pressure at the residence exceeds 80 psi, which is on the high side and will likely add stress to the components of the system. You may want to consider installing a regulator. Most regulators come factory pre-set at 60 psi which is the typical water pressure that is recommended for most residences.

Figure Set 22 - The water pressure was at or over 80 psi

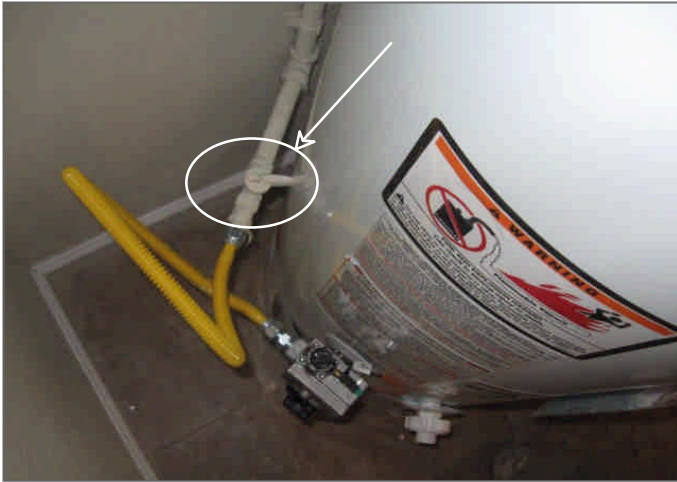
Figure Set 23 - The shut-off valve for the gas water heater would be difficult to access

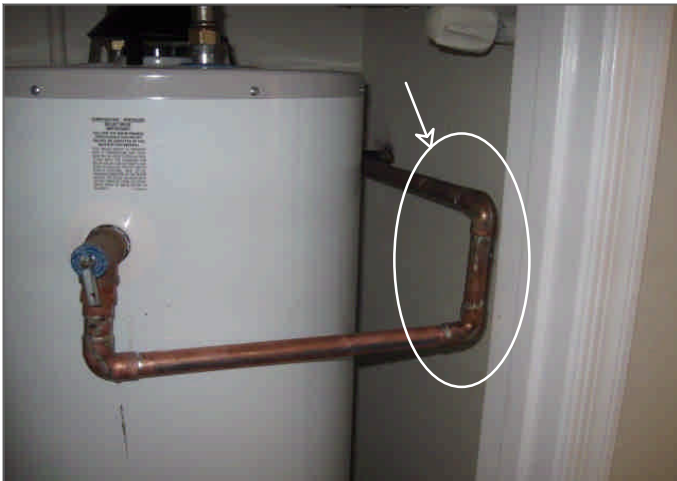
- 4.10 - The discharge pipe from the pressure relief valve has been incorrectly plumbed uphill. This is not permissible and the discharge pipe should be correctly plumbed, or the valve itself could be replaced with a Watts 210 shut-off valve, which serves the same purpose and meets the same safety requirement. However, a standard pressure relief valve must be present elsewhere on the system.

Figure Set 24 - The discharge pipe from the relief valve has been incorrectly plumbed uphill

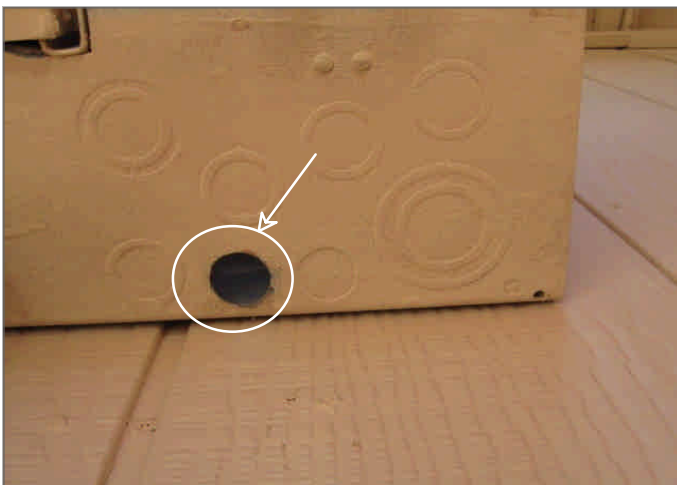
- 5.1 - One or more knock-outs are missing in the panel and should be closed for safety purposes. We recommend repair by a qualified and competent electrical contractor with remedy as necessary.

Figure Set 25 - One or more knock-outs are missing in the panel and should be closed for safety purposes

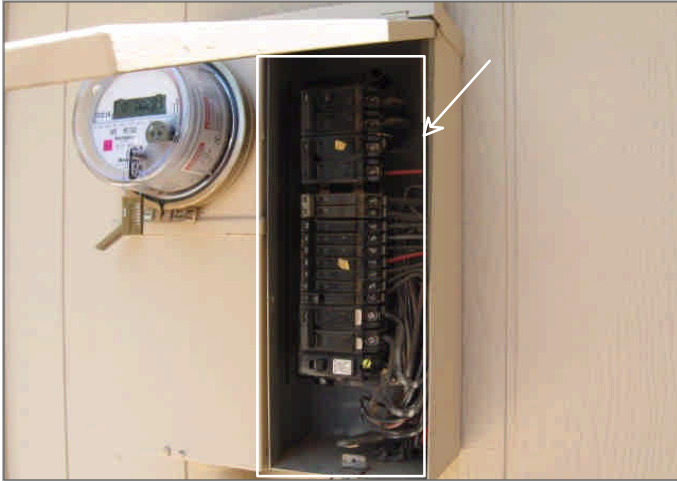
- 5.3 - The interior panel cover is missing, and should be replaced. We recommend further evaluation by a qualified and competent electrician with remedy as necessary.

Figure Set 26 - The interior panel cover is missing and should be replaced

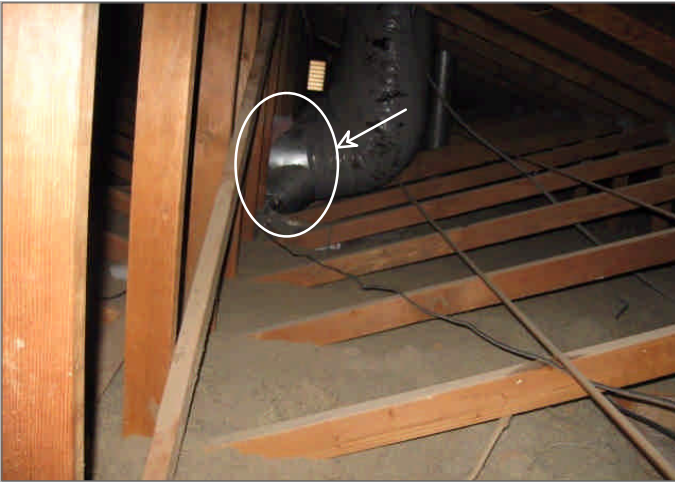
- 7.1 - Insulation and-or vapor retarders in unfinished spaces were observed to be missing which is not energy efficient and can allow moisture to accumulate and damage the surrounding materials. We recommend that you have this issue evaluated by a competent and licensed general contractor or HVAC contractor and corrected as required.

Figure Set 28 - Insulation or vapor retarders in unfinished spaces were observed to be missing and require servicing

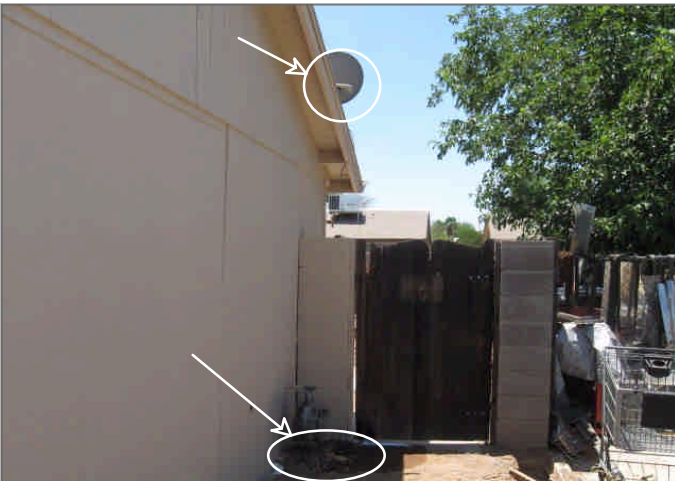
- 7.2 - Condensation should be directed to drain onto the ground beyond the foundation. Using a rain gutter splash block would be one way of doing this. In its present configuration it directs water onto the sidewalk which could make it slippery and a possible tripping hazard.

Figure Set 29 - Condensation should be directed to drain onto the ground beyond the foundation

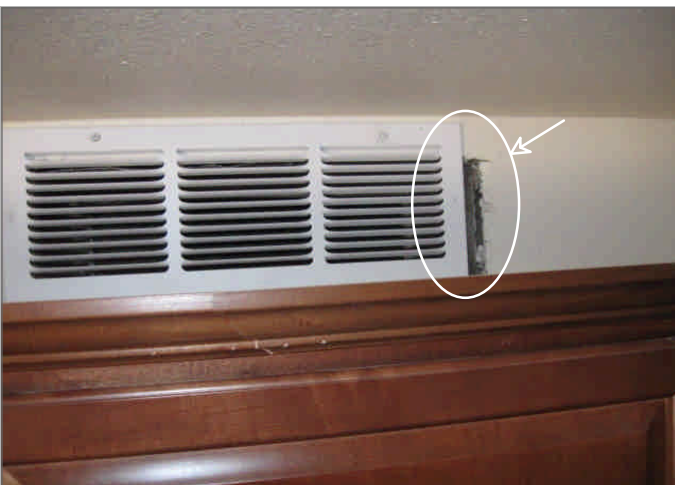
- 7.3 - A wall register in the kitchen is not trimmed correctly and should be repaired.

Figure Set 30 - A wall register is not trimmed correctly as indicated within the report and should be repaired

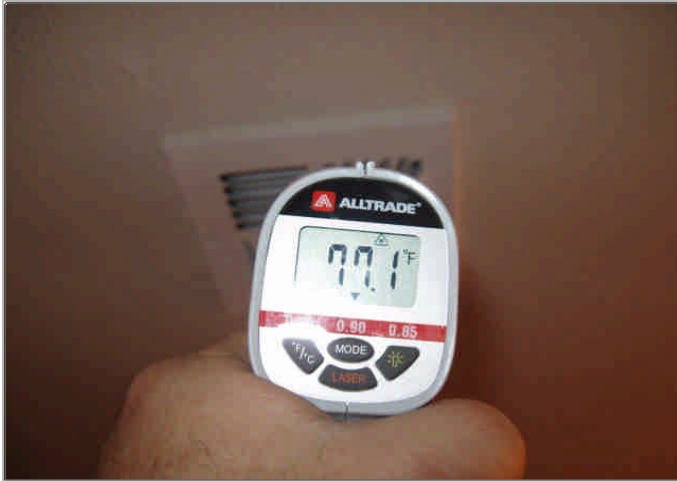
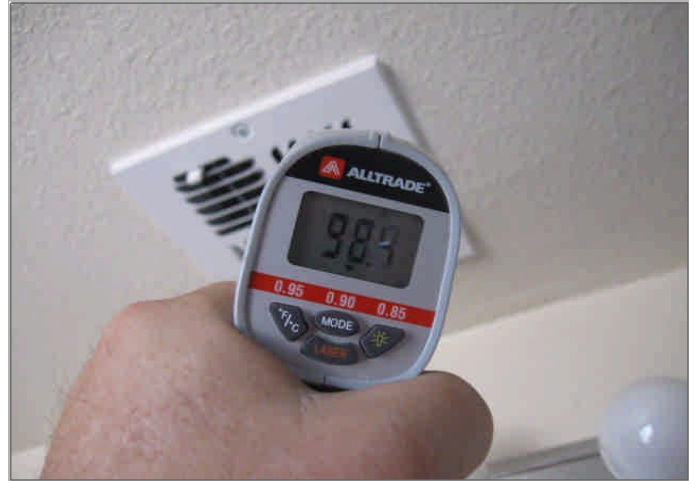
- 7.4 - The ducts are a modern flexible type that are comprised of an outer plastic sleeve and a clear inner liner that contains fiberglass insulation. However, both of the bathroom ducts appear to be kinked or separated and should be examined for evidence of rodent intrusion, and then reconnected and secured.

Figure Set 31 - One or more of the flexible ducts is separated and should be reconnected and secured

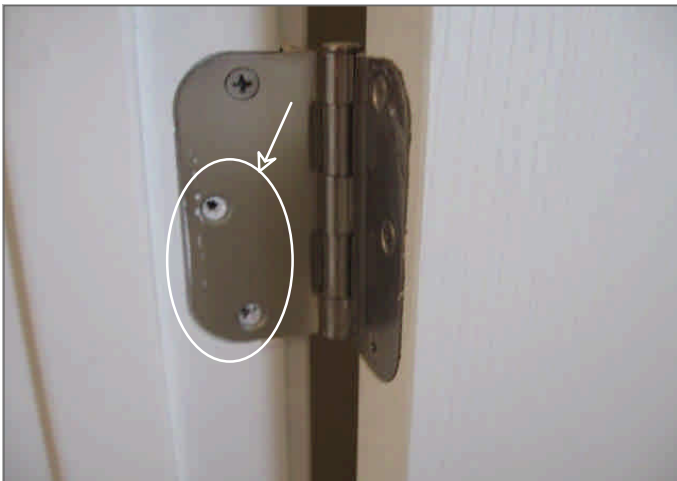
- 9.1 - One or more doors are missing screws in the hinges that should be installed.

Figure Set 32 - One or more doors are missing screws in the hinges that should be installed

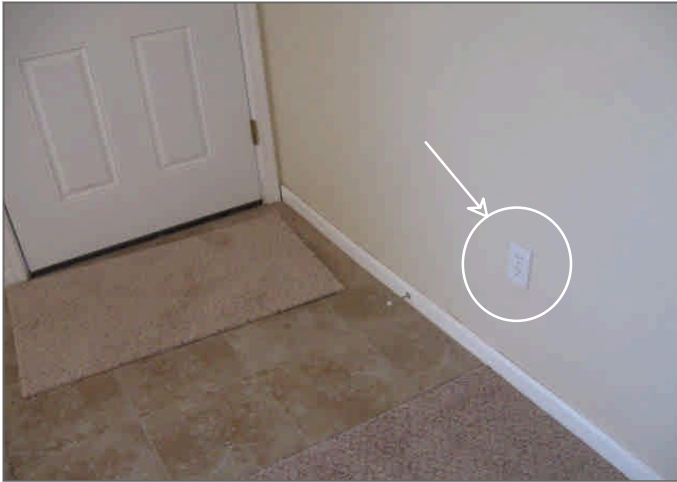
Figure Set 33 - One or more outlets did not have electricity and should be serviced

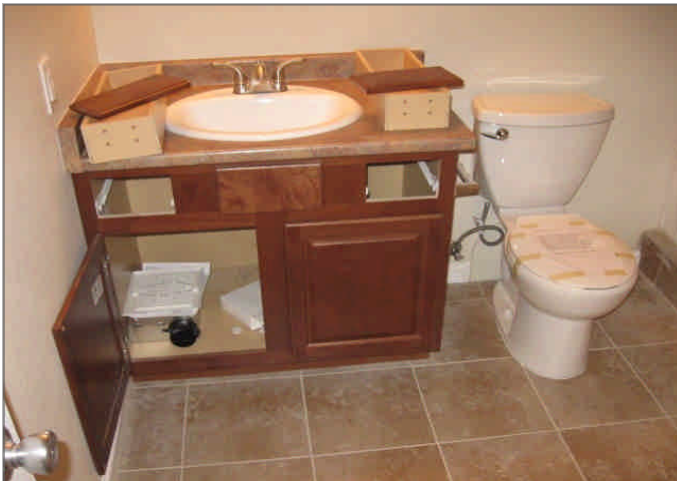
Figure Set 34 - The cabinet hardware needs maintenance service such as that to latches catches hinges or drawer glides

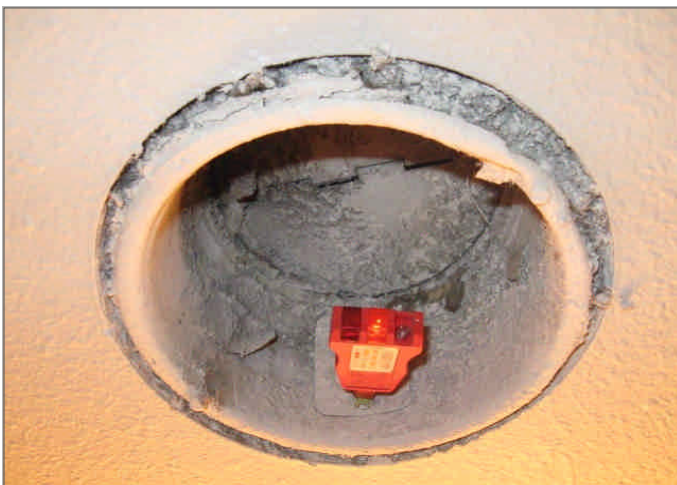
Figure Set 35 - The main bath exhaust fan was not installed and could not be tested

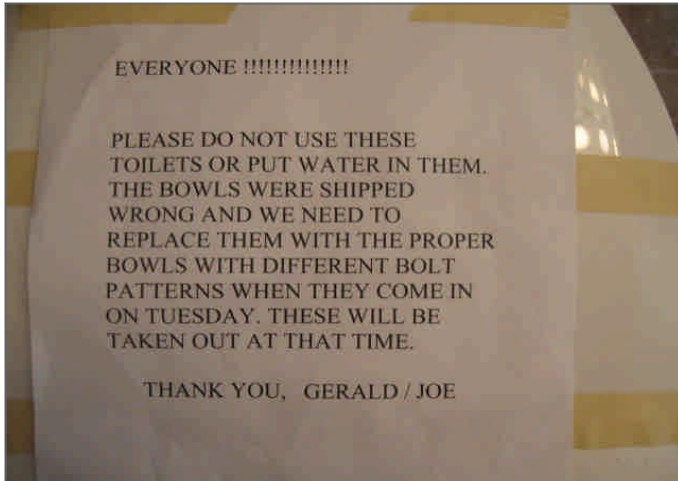
Figure Set 36 - The toilets were not installed at the time of my inspection and should be demonstrated by the seller

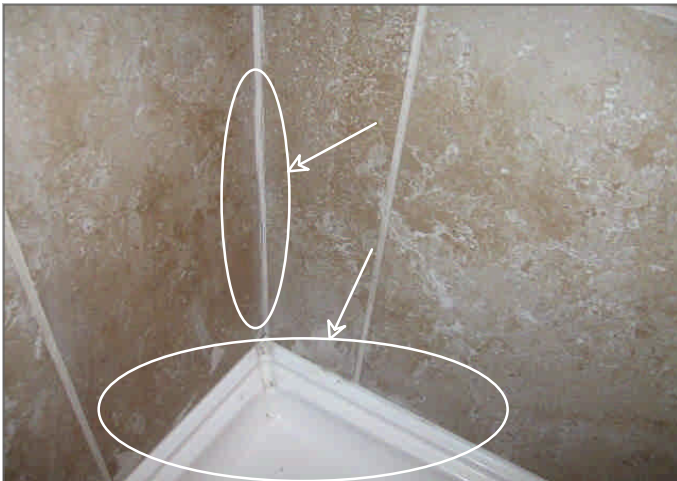
11.5 - There are open grout or caulk-joints around the shower area that should be sealed to prevent moisture damage.

Figure Set 37 - There are openings around the shower area that should be sealed to prevent moisture damage

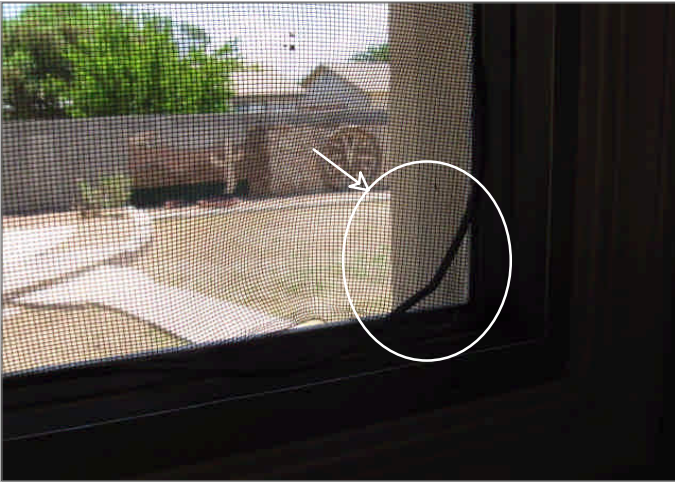
11.6 - A window screen in the master bathroom is torn and should be repaired.

Figure Set 38 - A window screen in the master bathroom is torn and should be repaired

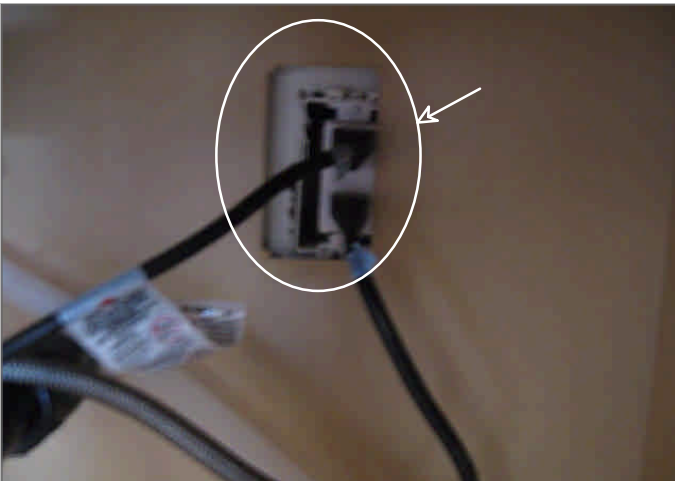
12.1 - There is an electrical outlets under the sink that is missing an outlets cover. For safety reasons, we strongly recommend that all electrical outlets have proper covers installed. We recommend further evaluation by a qualified and competent electrical contractor with remedy as necessary.

Figure Set 39 - There are electrical outlets that are missing outlets covers and present a safety risk

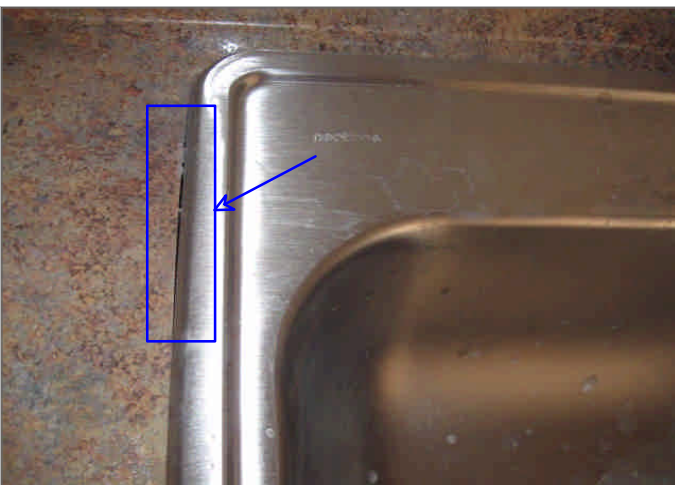
12.3 - An open seam between the sink and the counter top needs to be caulked or re-grouted to forestall moisture intrusion.

Figure Set 40 - An open seam between the sink and the counter top should be caulked

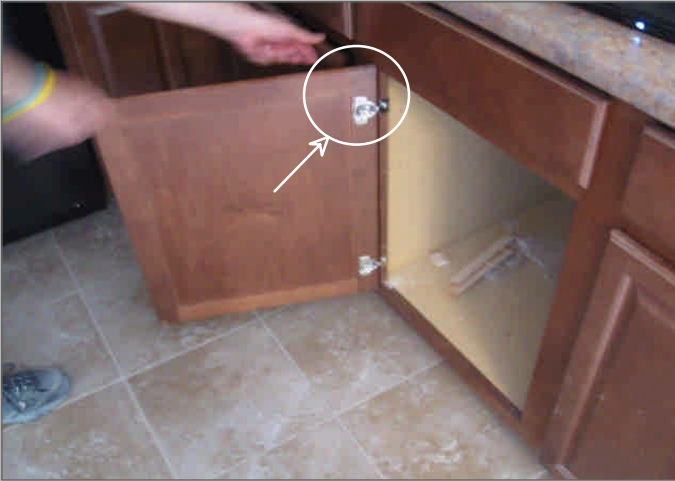
Figure Set 41 - The cabinets would need typical hardware service and or maintenance to work well

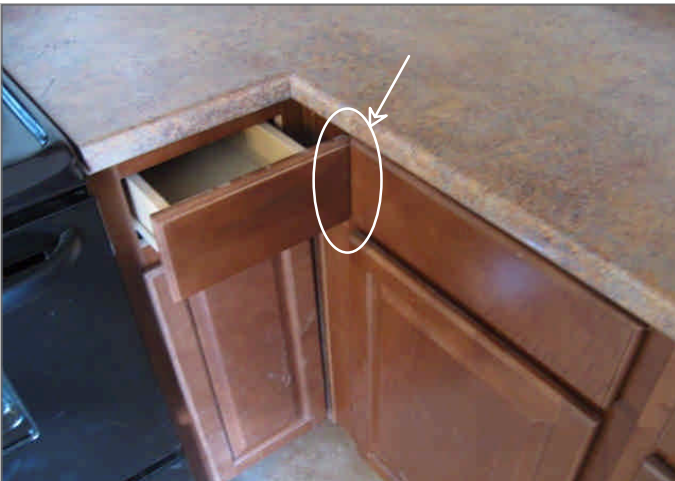
Figure Set 42 - A cabinet door does not open completely because it hits the adjacent drawer

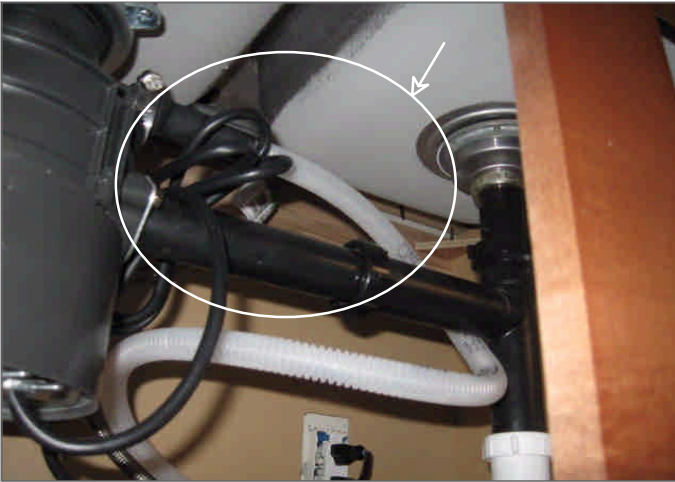
Figure Set 43 - The dishwasher does not have a high loop on the drain line

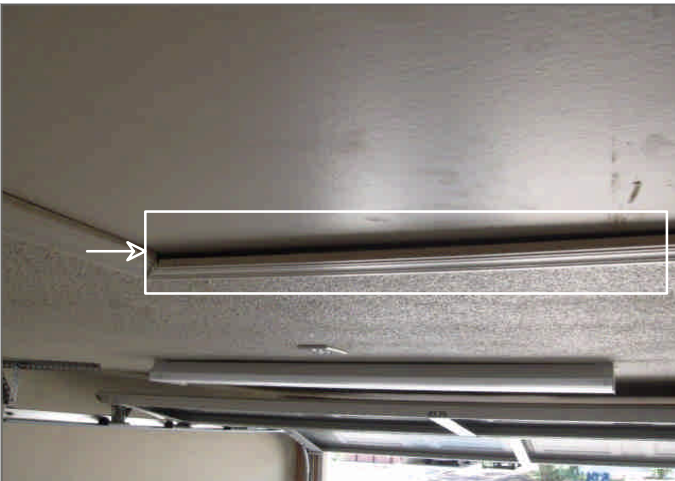
17.1 - The voids around the attic hatch opening must be repaired in order to maintain the necessary firewall separation between the garage and the residence.

Figure Set 44 - The voids around the attic hatch opening have compromised the firewall and should be repaired

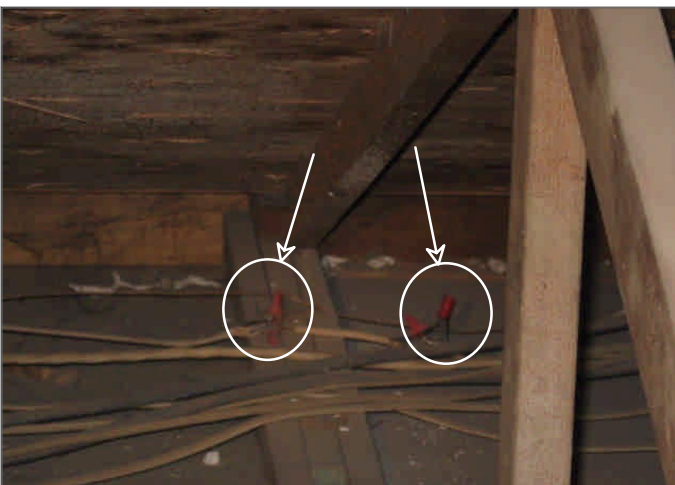
18.1 - An electrical connection has been incorrectly made outside of a junction box, which is a potential fire-hazard. All such connections should be made inside a junction box, in order to contain any arcing or sparking within the box.

Figure Set 45 - An electrical connection has been made incorrectly outside of a junction box

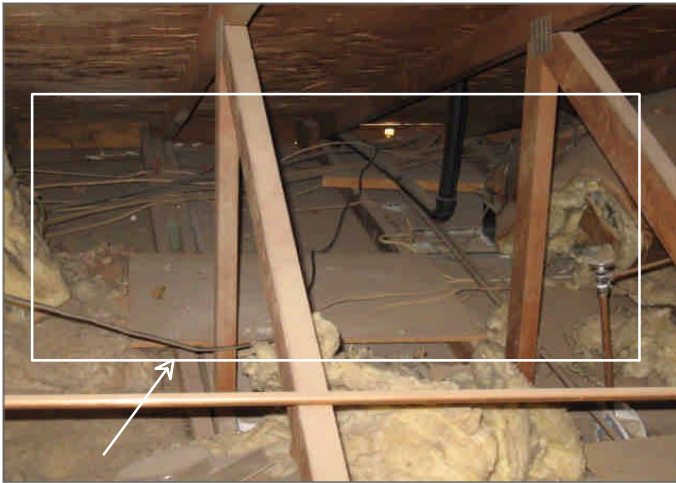
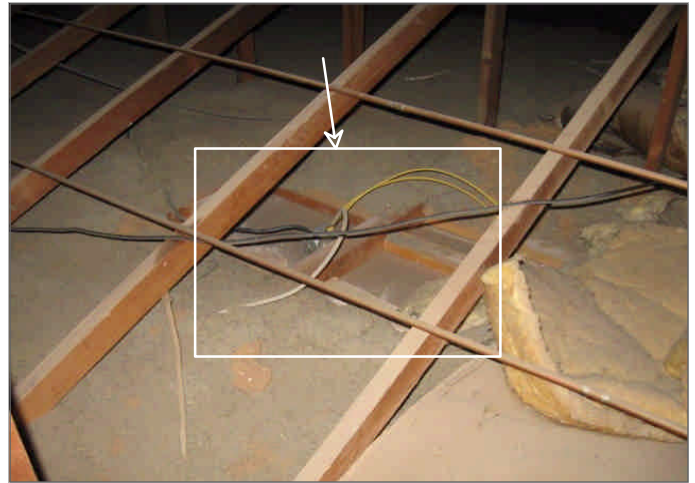
Figure Set 46 - There is a lack of insulation in a living space

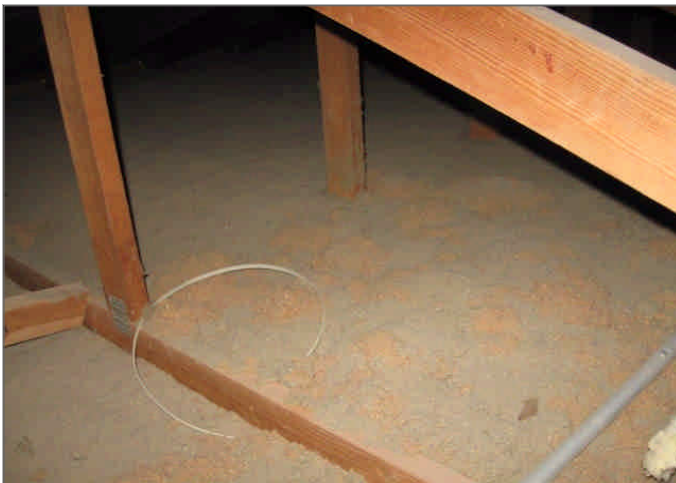
18.3 - The attic is insulated, with approximately three-five inches of blown-in cellulose. Current standards call for nine and even twelve inches, which we do not necessarily recommend upgrading unless the savings in energy costs warrants the expenditure.

Figure Set 47 - The attic is insulated with approximately three-five inches of blown-in cellulose
